The Conservation Office

Statement of Significance Example 2:

Tregillard (Grade II)

Part 1: The church in its rural environment

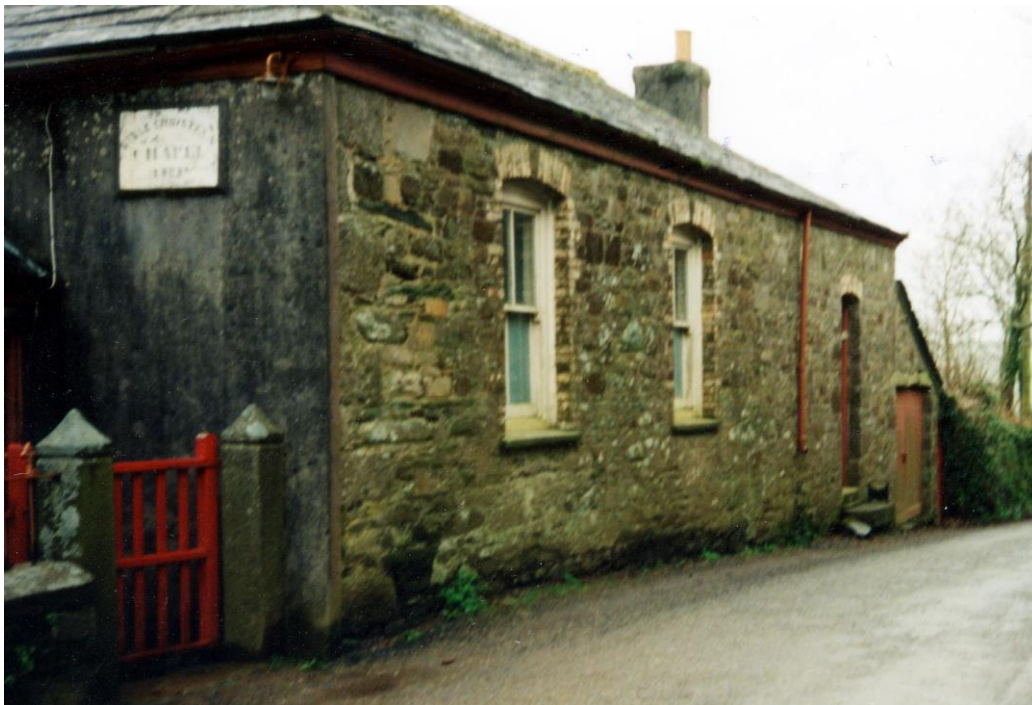
The chapel showing the south elevation

The chapel is small (8m by 5m), and the adjoining Sunday School smaller still (5m by 3m). The walls are of coursed rubble with rough-cast rendering to the entrance elevation. The roofs are covered in Cornish slate. There are two original hornless sash windows on each of the side elevations (moderate significance). The Sunday School continues under the same roof and the stable, in the same materials, is a lean-to at a slightly lower level.
