Lozells Methodist Community Centre – Lead Theft and Fabric Repairs

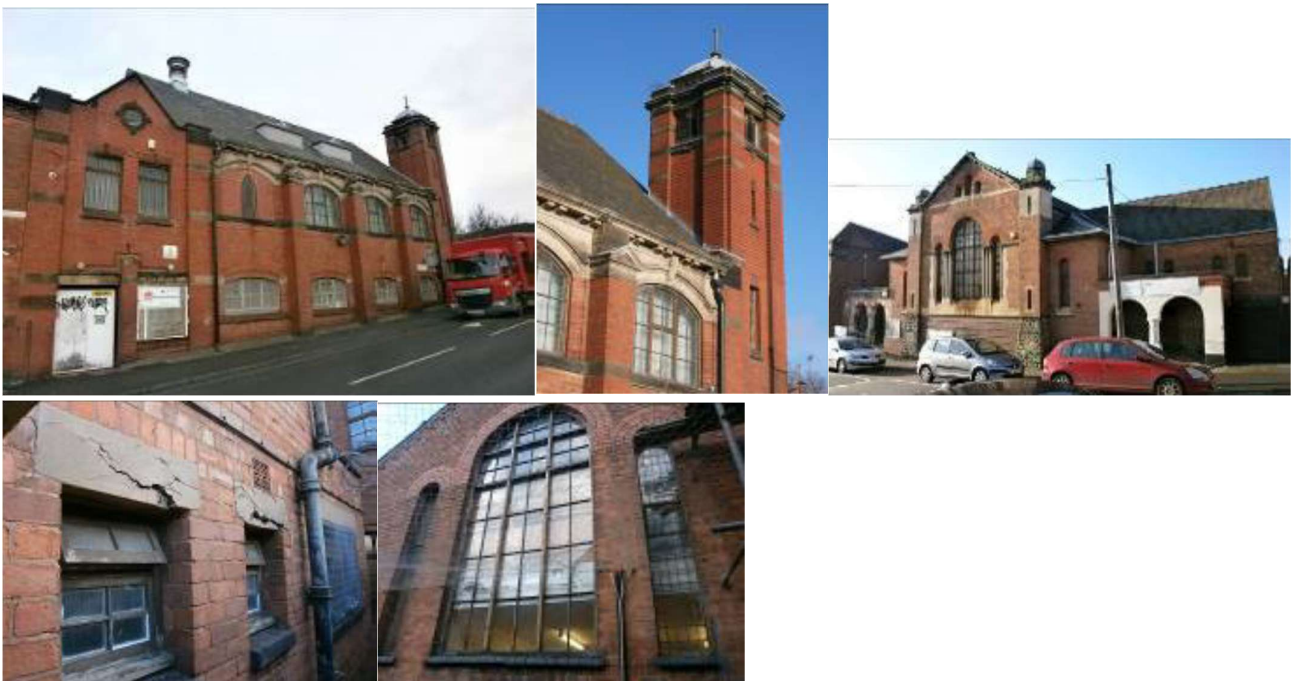
Following a recent Quinquennial inspection it was clear that the historic building required urgent fabric repairs. So the trustees, acting as good custodians, set about finding a suitable professional to assist them. He duly wrote a schedule of works and once all the consents were recorded on the Methodist Church's online systems the works commenced. This included some external redecoration, brickwork repointing, brickwork repairs, concrete lintel repairs, replacement of rainwater goods and the removal of some protective grilles (see image below). The total cost of the works was approximately £120,000.

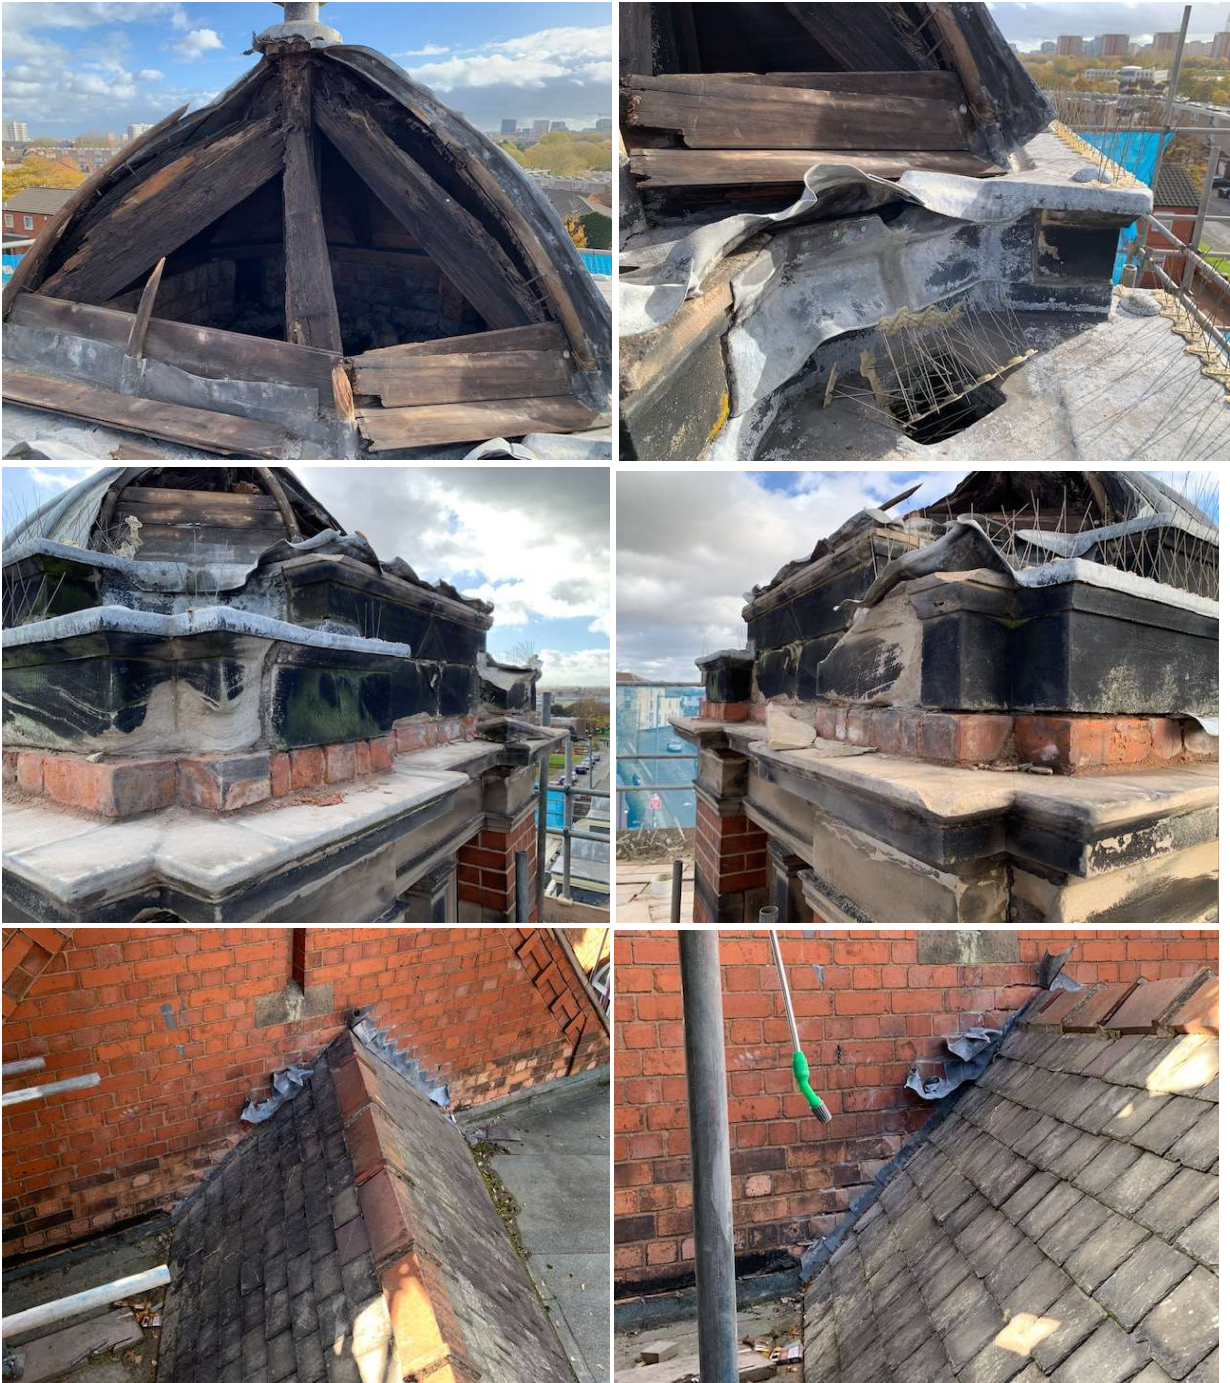
Unfortunately, during the works thieves climbed the scaffolding and stole the lead cupola covering. This was discovered by the builders as they resumed the works after the weekend. The matter was reported to the police and a crime officer visited the property but unfortunately, no arrests were made and the thieves

were never caught. Extensive damage was caused as shown in the images below:

This left the trustees in an unenviable position, especially as their insurers would not cover the claim because the Smartwater marking system had not been applied to the lead work prior to the theft. This was despite the fitting of a scaffold alarm and netting during the work, measures which the thieves had managed to circumnavigate. Approximately 50% of the lead sheeting to the cupola along with supporting boarding were stripped, 40% of the lower lead flashing/capping to the projecting parapet were forcibly removed, and a further 10% of supporting boarding to the cupola was damaged, along with damage to the sandstone string course and the now exposed brickwork where sections had become loose or missing.

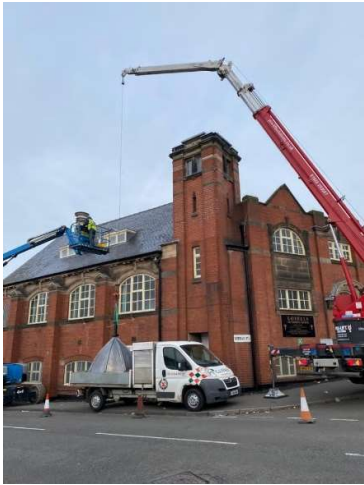
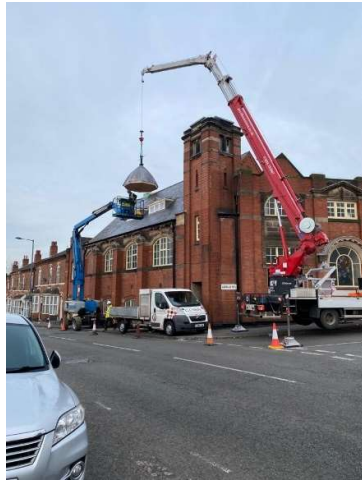
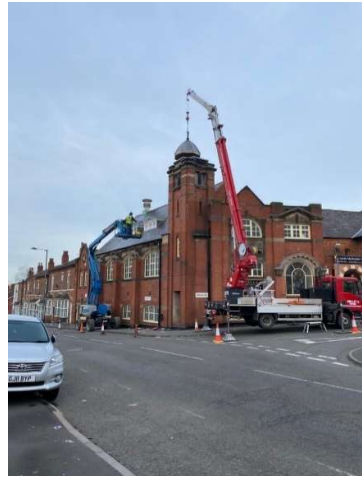
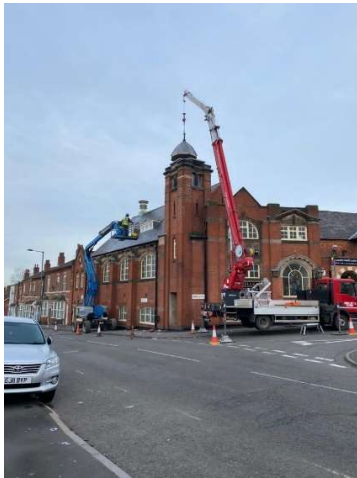
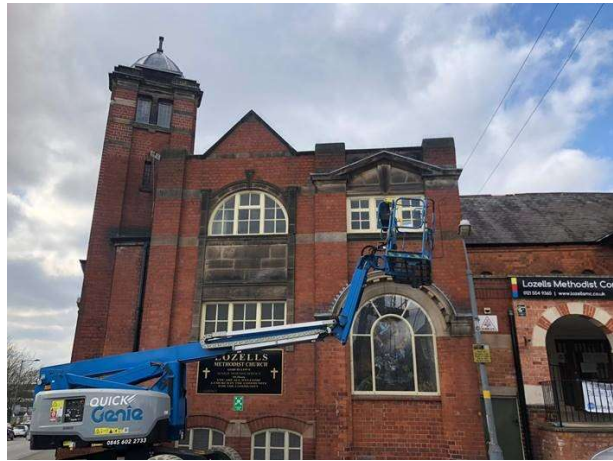
The Cupola had to be removed for the repairs to be completed. Following this it was lowered and fixed in one operation onto the tower roof by crane and flashed/weatherproofed in position. The replacement lead cost the church a further £20,000. The impressive photographs below show this work in progress.

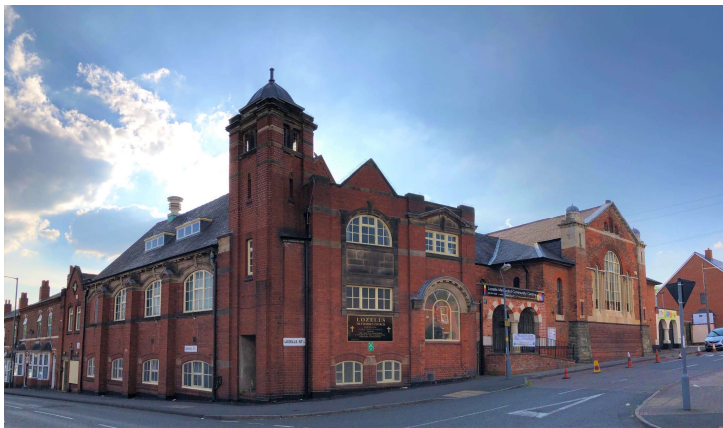
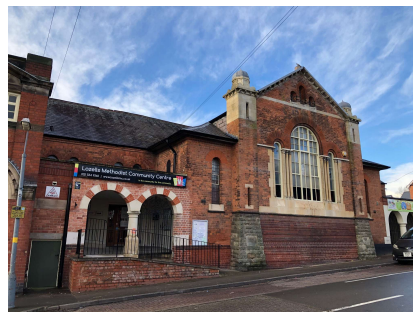
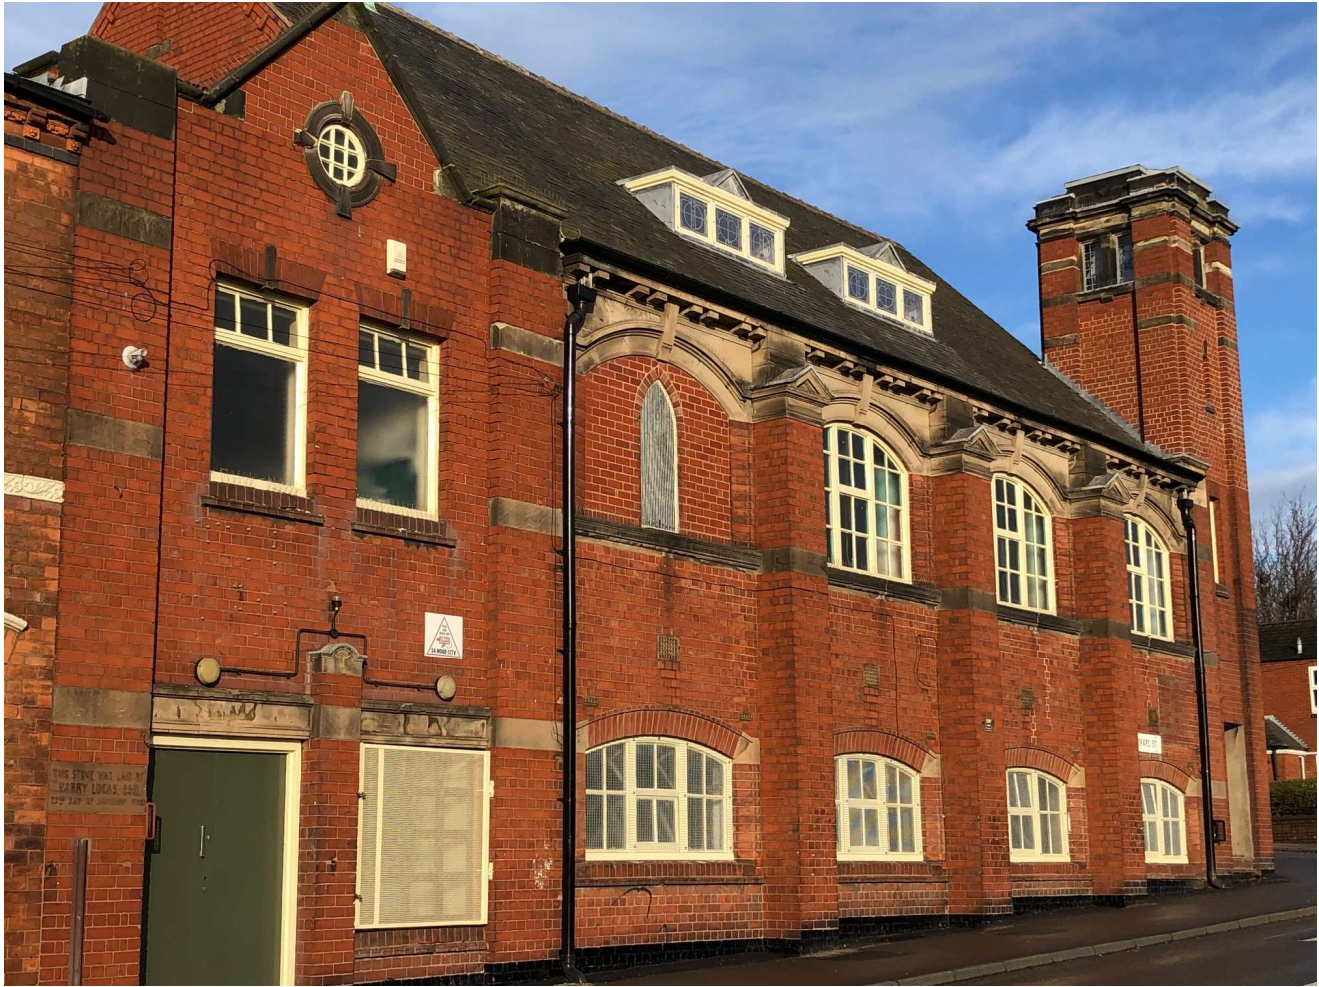
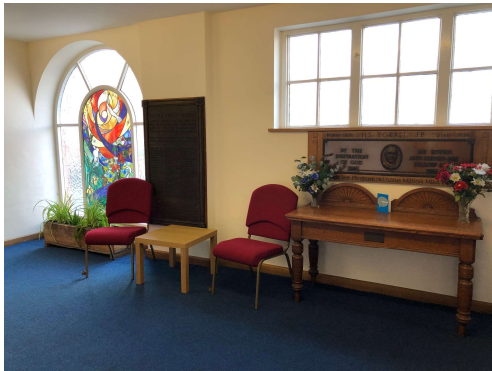
The church, with its repointed brickwork and repainted windows, now looks welcoming and bright, and fit for 21st Century use.
